MARINE INVESTIGATION REPORT

M03M0077

FIRE AND SINKING

SMALL FISHING VESSEL *SILENT PROVIDER*

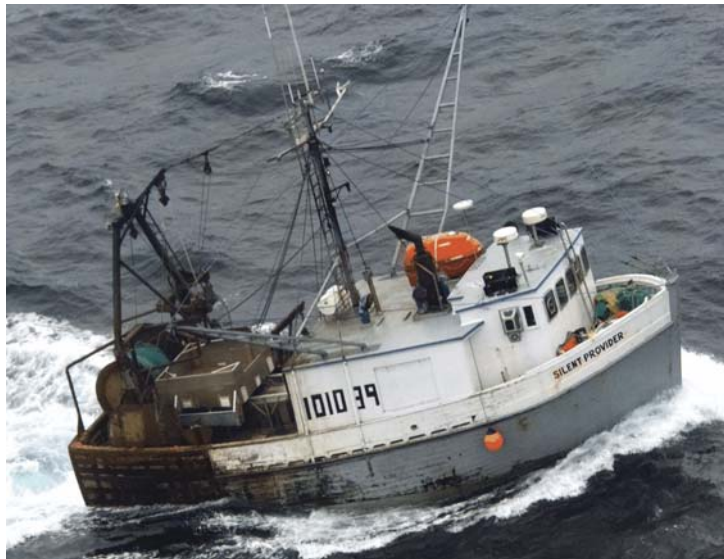
Photo 1. Fishing Vessel *Silent Provider*

The *Silent Provider* eventually burned to the waterline and sank. It was declared a total loss.

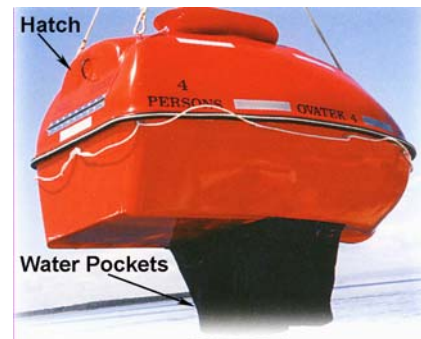
Photo 2. Ovatek 4

The Ovatek 4 water pockets fill with seawater when the liferaft is launched. These bags are intended to stabilize the craft during boarding and when in a seaway (in open seas). When stowed, the bags sit under the liferaft in a shallow cavity within the stowage cradle. Although protected from sunlight, salt water can seep into the cavity and saturate the textile. The stowage cradle has drain holes, but salt crystals

left from the evaporating water remain imbedded in the fabric. In contrast, the Ovatek 7 does not have water pockets. It has an internal ballast arrangement whereby seawater enters openings in the hollow fibreglass keel.

The nylon water pockets had been severely damaged with multiple tears in the material. Although the crew of the *Silent Provider* reported that some damage to these bags occurred during efforts to stabilize and right the liferaft when trying to board, some additional damage may have been incurred during the salvage and recovery of the liferaft. It was not possible to quantify the extent of the damage incurred solely during the boarding attempts.

- Prototype assessment is ongoing to replace the textile water pocket arrangement on the Ovatek 4 with an integrated fibreglass system similar to that of the Ovatek 7.
